# Old & New Victoria Dams

## - History & Statistics

(- photographic copies of public information panels previously at Old Victoria Dam)

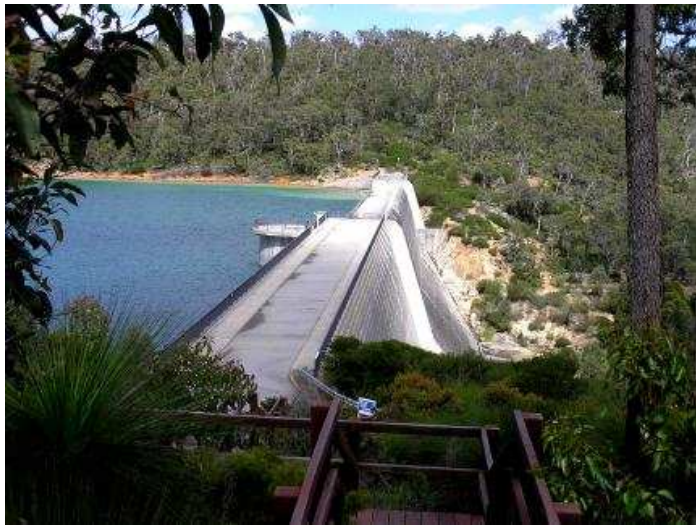
**New Victoria Dam**  
(opened Nov. 1991)

The New Victoria Dam supplies water to the hills suburbs of Lesmurdie and Kalamunda and augments supplies of water to the Perth metropolitan area during times of peak demand.

## New Technology—Roller Compacted Concrete

Roller Compacted Concrete (RCC) was first used in dam construction in 1980 and since that time the RCC technique has gained worldwide acceptance. New Victoria Dam was the first RCC dam in Western Australia and the fifth and largest RCC dam completed in Australia.

RCC is a no-slump concrete spread and compacted using earthmoving equipment. The RCC was batched on-site in a continuous mixing batch plant, delivered onto the dam wall by conveyors and discharged into dump trucks. The trucks transported the concrete to the point of placement where it was spread by dozer and compacted into layers using vibratory rollers.

The faces of the dam were formed using interlocking concrete facing elements, horizontally slipformed—much the same way as road kerbs—with a total length of 25 kilometres of facing elements being needed to complete the dam.

The stepped downstream face of the dam will dissipate as much as 70 to 80% of the energy of the flow passing over the spillway.

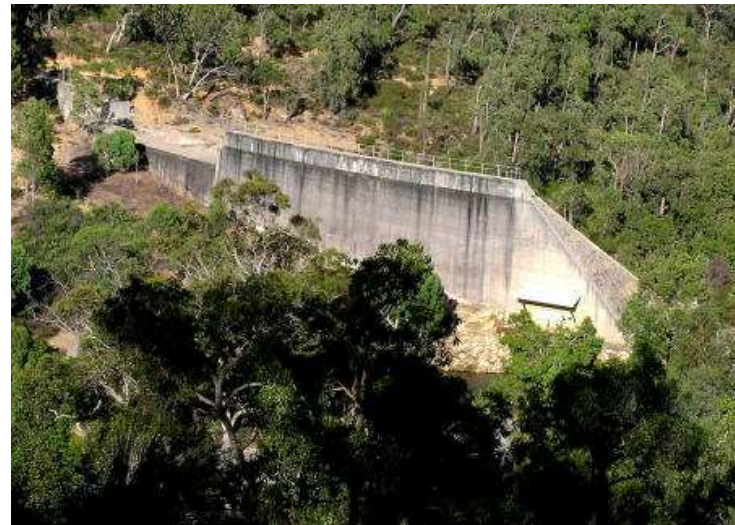
**Old Victoria Dam (part of original wall)**  
(opened Oct. 1891)

The original Victoria Dam was completed in 1891, thereby forming the source of Perth's first permanent city water supply. The reservoir capacity was 'considerably over a year's supply for a population of 10 000 persons'.

In 1887 when the Victoria Dam was designed, the use of concrete for construction of dam walls was a relatively new phenomenon. The dam relied on a combination of arching and gravity for its stability.

Leakage through the dam wall was leaching lime and forming voids, thus reducing the strength of the concrete. Repairs to reduce this leakage were carried out as early as 1912. In 1966 a reinforced concrete upstream facing was installed to successfully reduce seepage through the wall.

In 1989 the decision was taken to replace the original Victoria dam with a new, larger dam. Sufficient of the original wall was demolished using explosives to allow free passage of flood overflow from the upstream New Victoria Dam.
